Navajo Abandoned Uranium Mine

Site Screen Report

Section 9 Lease AUM Site

January 2011

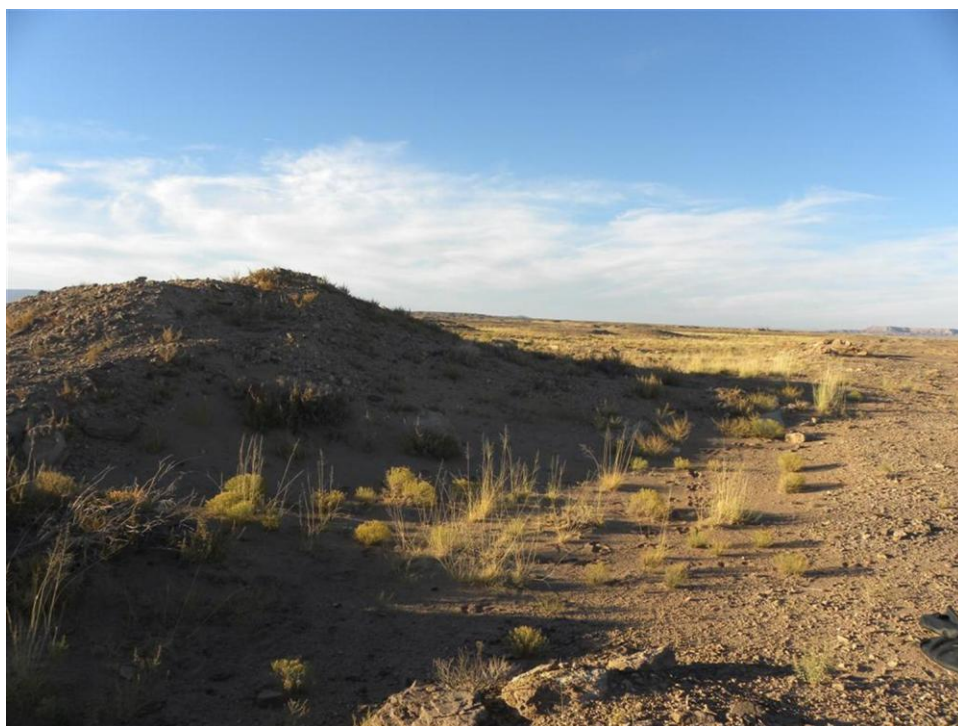
Waste piles spread throughout entire central part of site, primarily surrounding the concrete structure foundation, total estimated size of 1,000' x 250' x 5'

Photo 2. Section 9 Lease, Site #457, waste pile

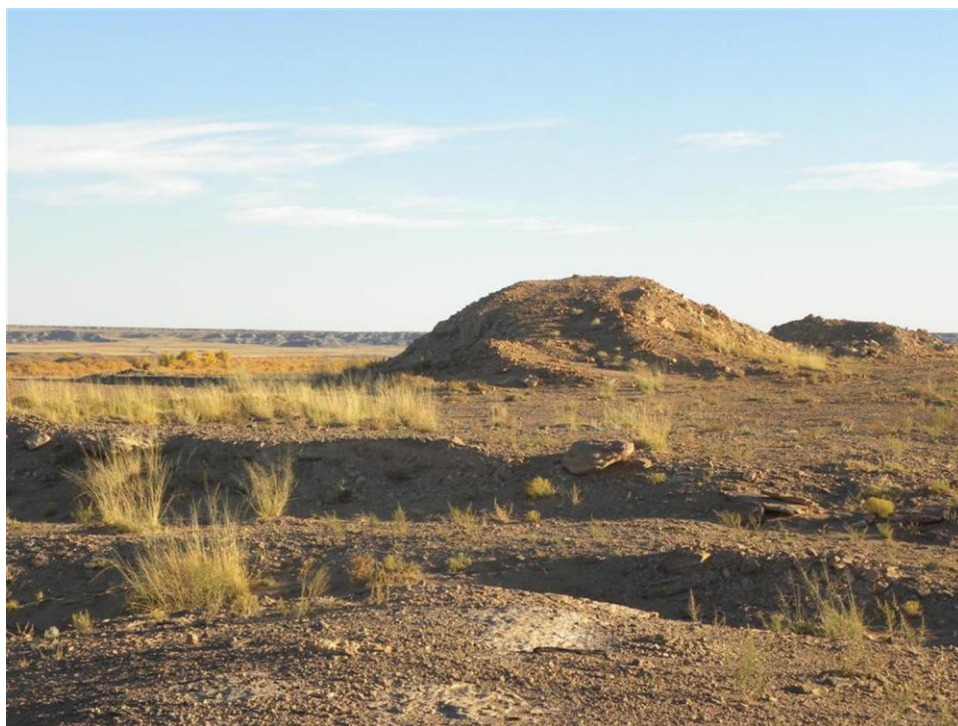
Photo 3. Section 9 Lease, Site #457, waste piles

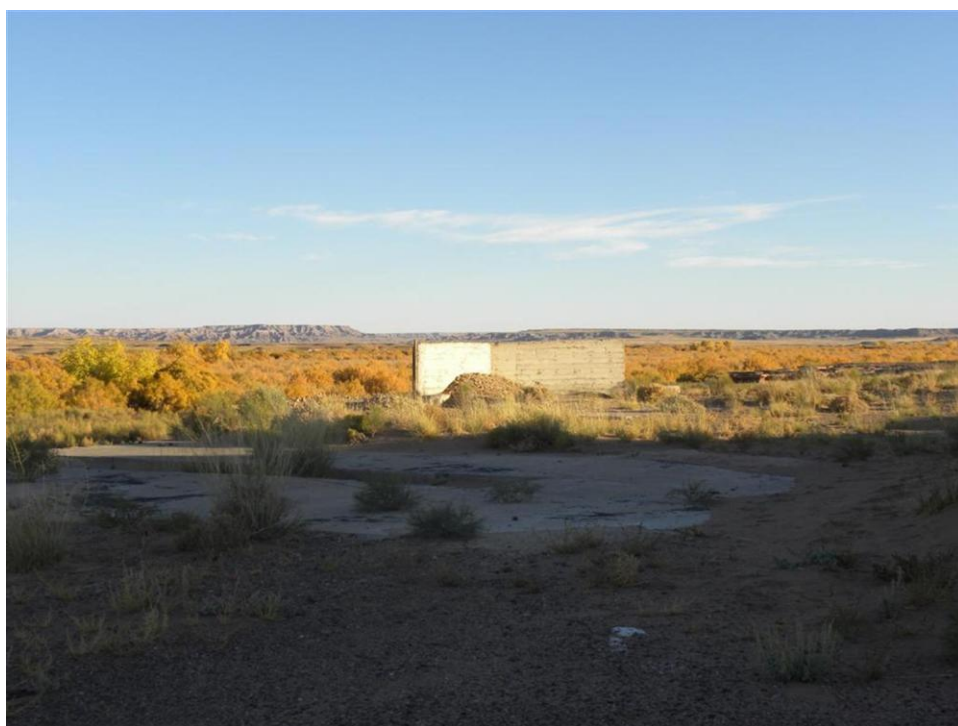
A concrete foundation and 2 walls from a former structure were found in the center of the site, the foundation was spread out between 2 levels, covering an estimated area of 100' x 50'. Two of the walls were still partially intact. The lower wall is approximately 30' high. Two chutes are still visible leading between the levels. A smaller 20' x 20' foundation was found approximately 300' south of large foundation. Other various metal and wood debris was found throughout site.

Photo 4. Section 9 Lease, Site #457, concrete structure area

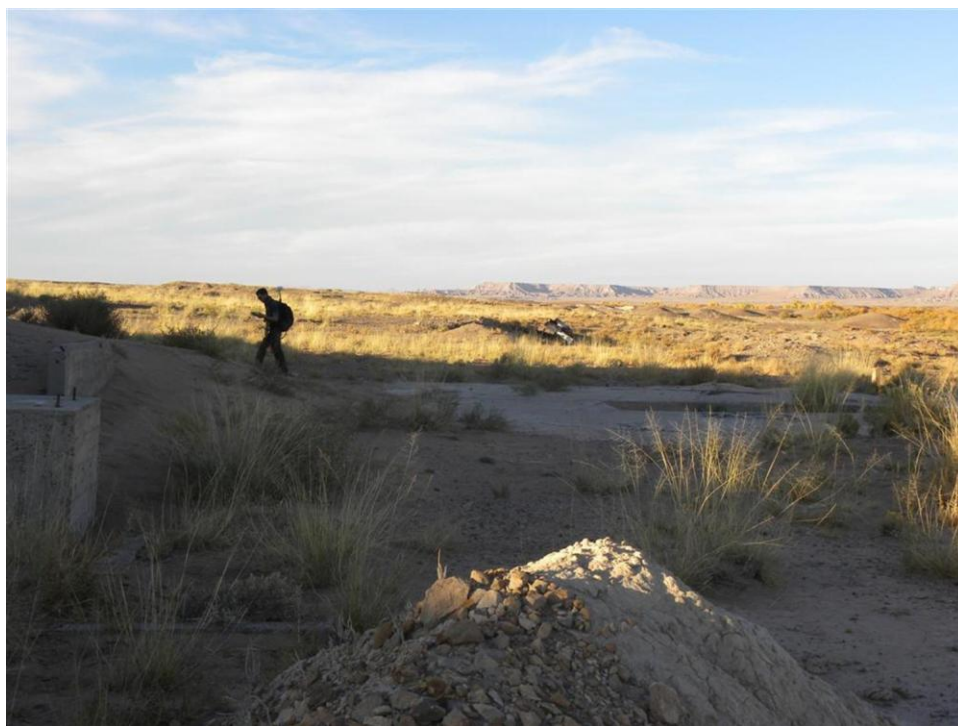
Waste piles atop the foundation area were found at levels up to 1,000,000 cpm

Photo 8. Section 9 Lease, Site #457, concrete structure area waste pile

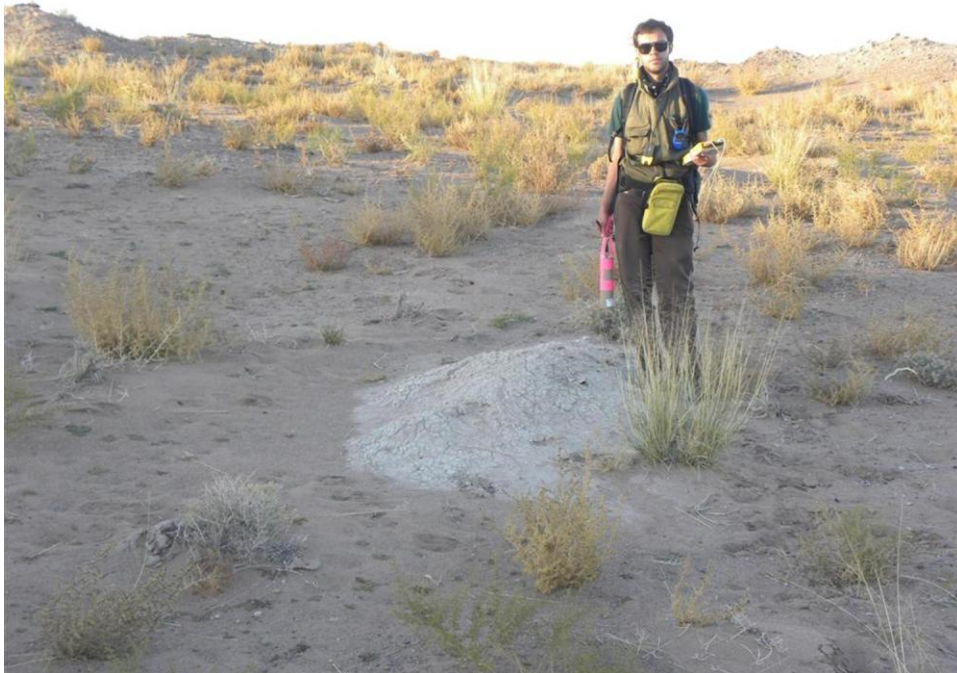
Photo 12. Section 9 Lease, Site #457, concrete structure area waste pile, gamma readings approximately 1,000,000 cpm

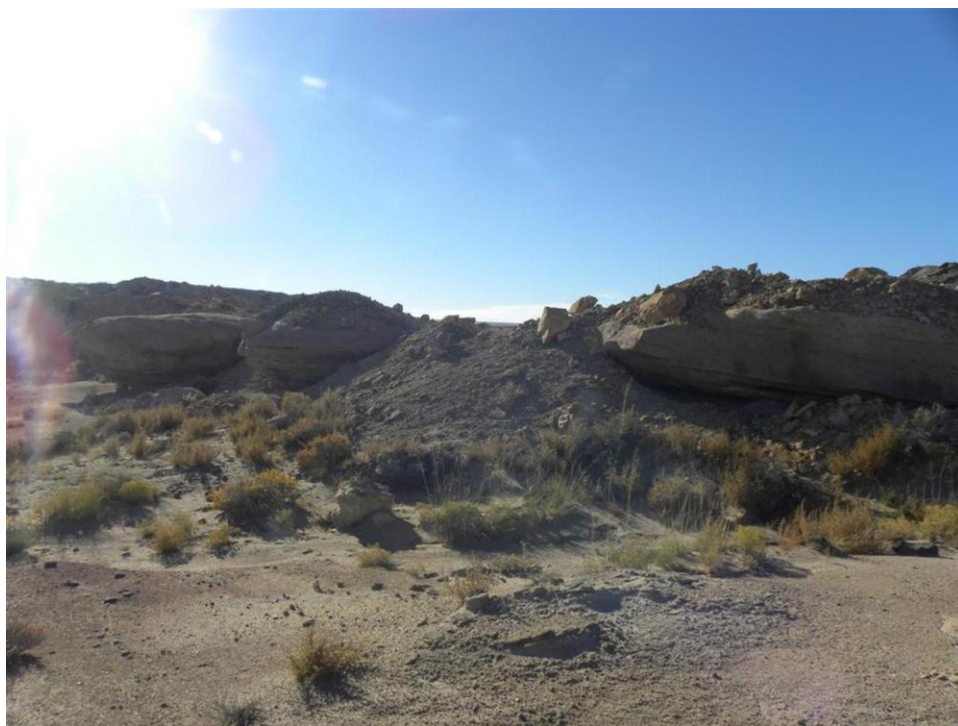
Majority of site is a large waste pile, extends S past the site boundaries, estimated size of 750' x 300' x 5'

Photo 26. Section 9 Lease, Site #458, waste pile

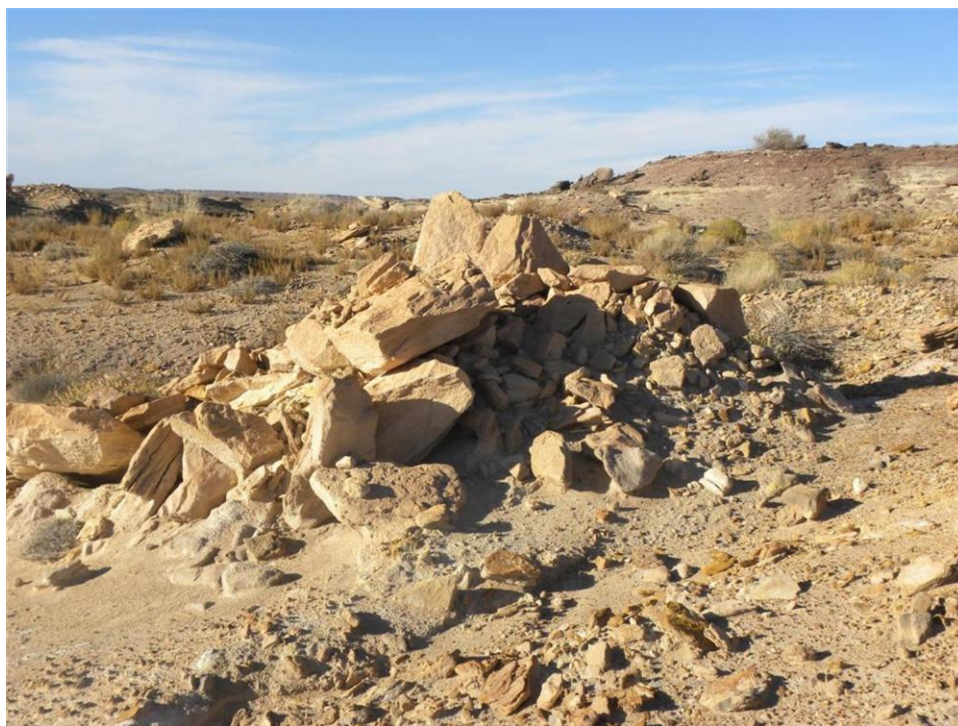
Photo 30. Section 9 Lease, Site #458, waste pile, gamma readings approximately 1,000,000 cpm

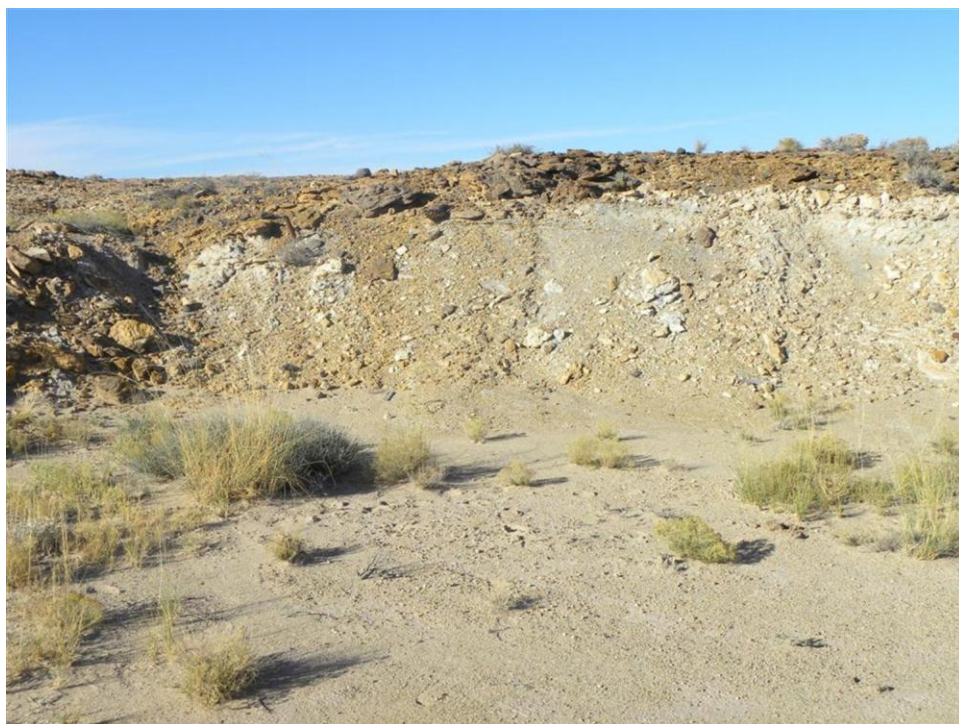
7 Waste piles: 2 small piles 6' x 4' x 2.5', yellow-brown upstream of N gully; 1 medium pile, 10' x 8' x 4', yellow brown upstream of N gully; 4 large piles, 20' diameter x 15' h, yellow brown, near open pit

Photo 34. Section 9 Lease, Site #459, waste piles

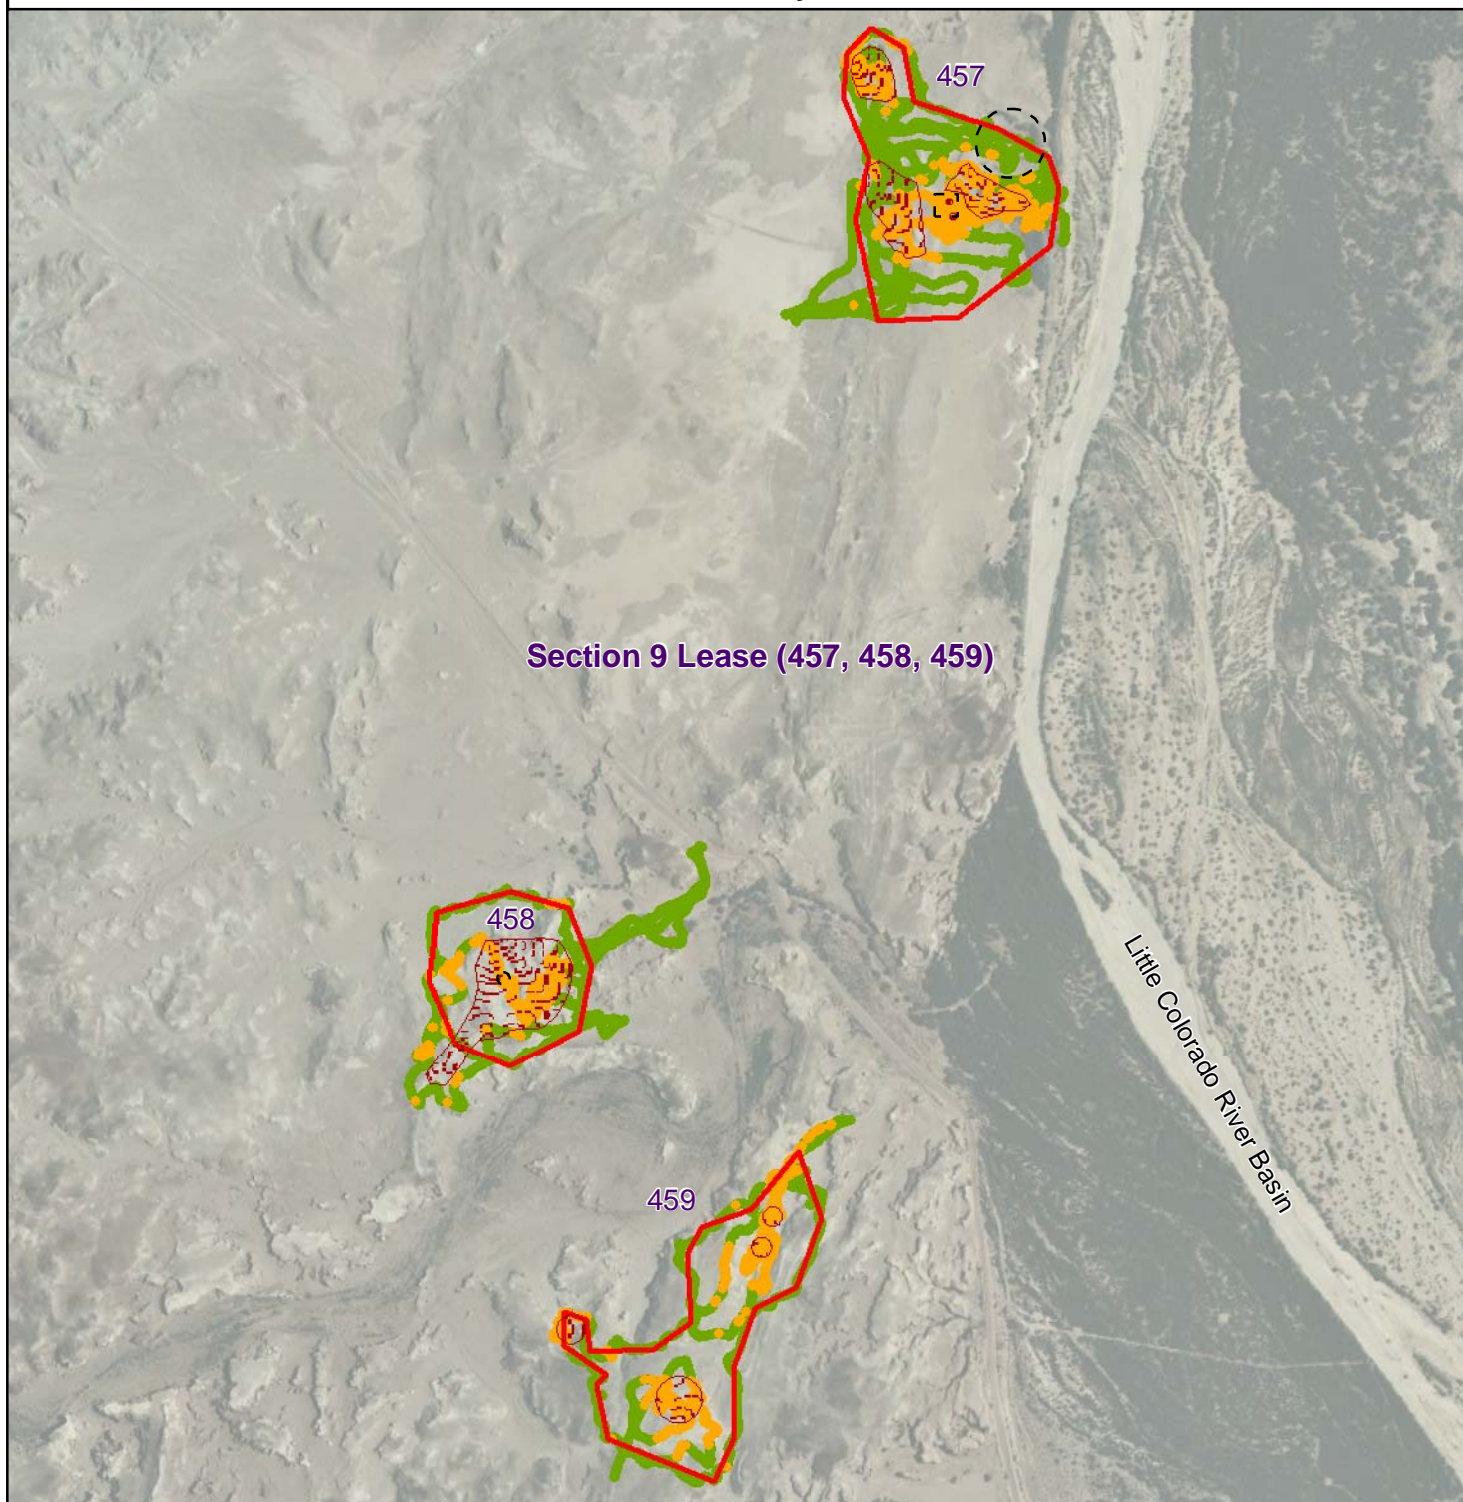
**Figure 1 - Gamma Radiation Measurements, Above Two Times Background
Section 9 Lease (457, 458, 459)
Coconino County, Arizona**

Gamma survey conducted 11/2010
Measured as counts per minute (cpm)

Average background 15,626 cpm

A total of 6,717 gamma radiation measurements were collected from the mine site, ranging from 11,616 cpm to 999,960 cpm. The measurements collected throughout the concrete structure foundation area were found at levels ranging from approximately 50,000 cpm (bare cement foundation) to 1,000,000 cpm (small dirt piles atop foundation), at the waste piles throughout the site at levels ranging from approximately 40,000 cpm to 1,000,000 cpm, and at the former pond area and downstream drainage at maximum levels of approximately 100,000 cpm. The measurements are represented in Figures 1, 2, 3, and 4.

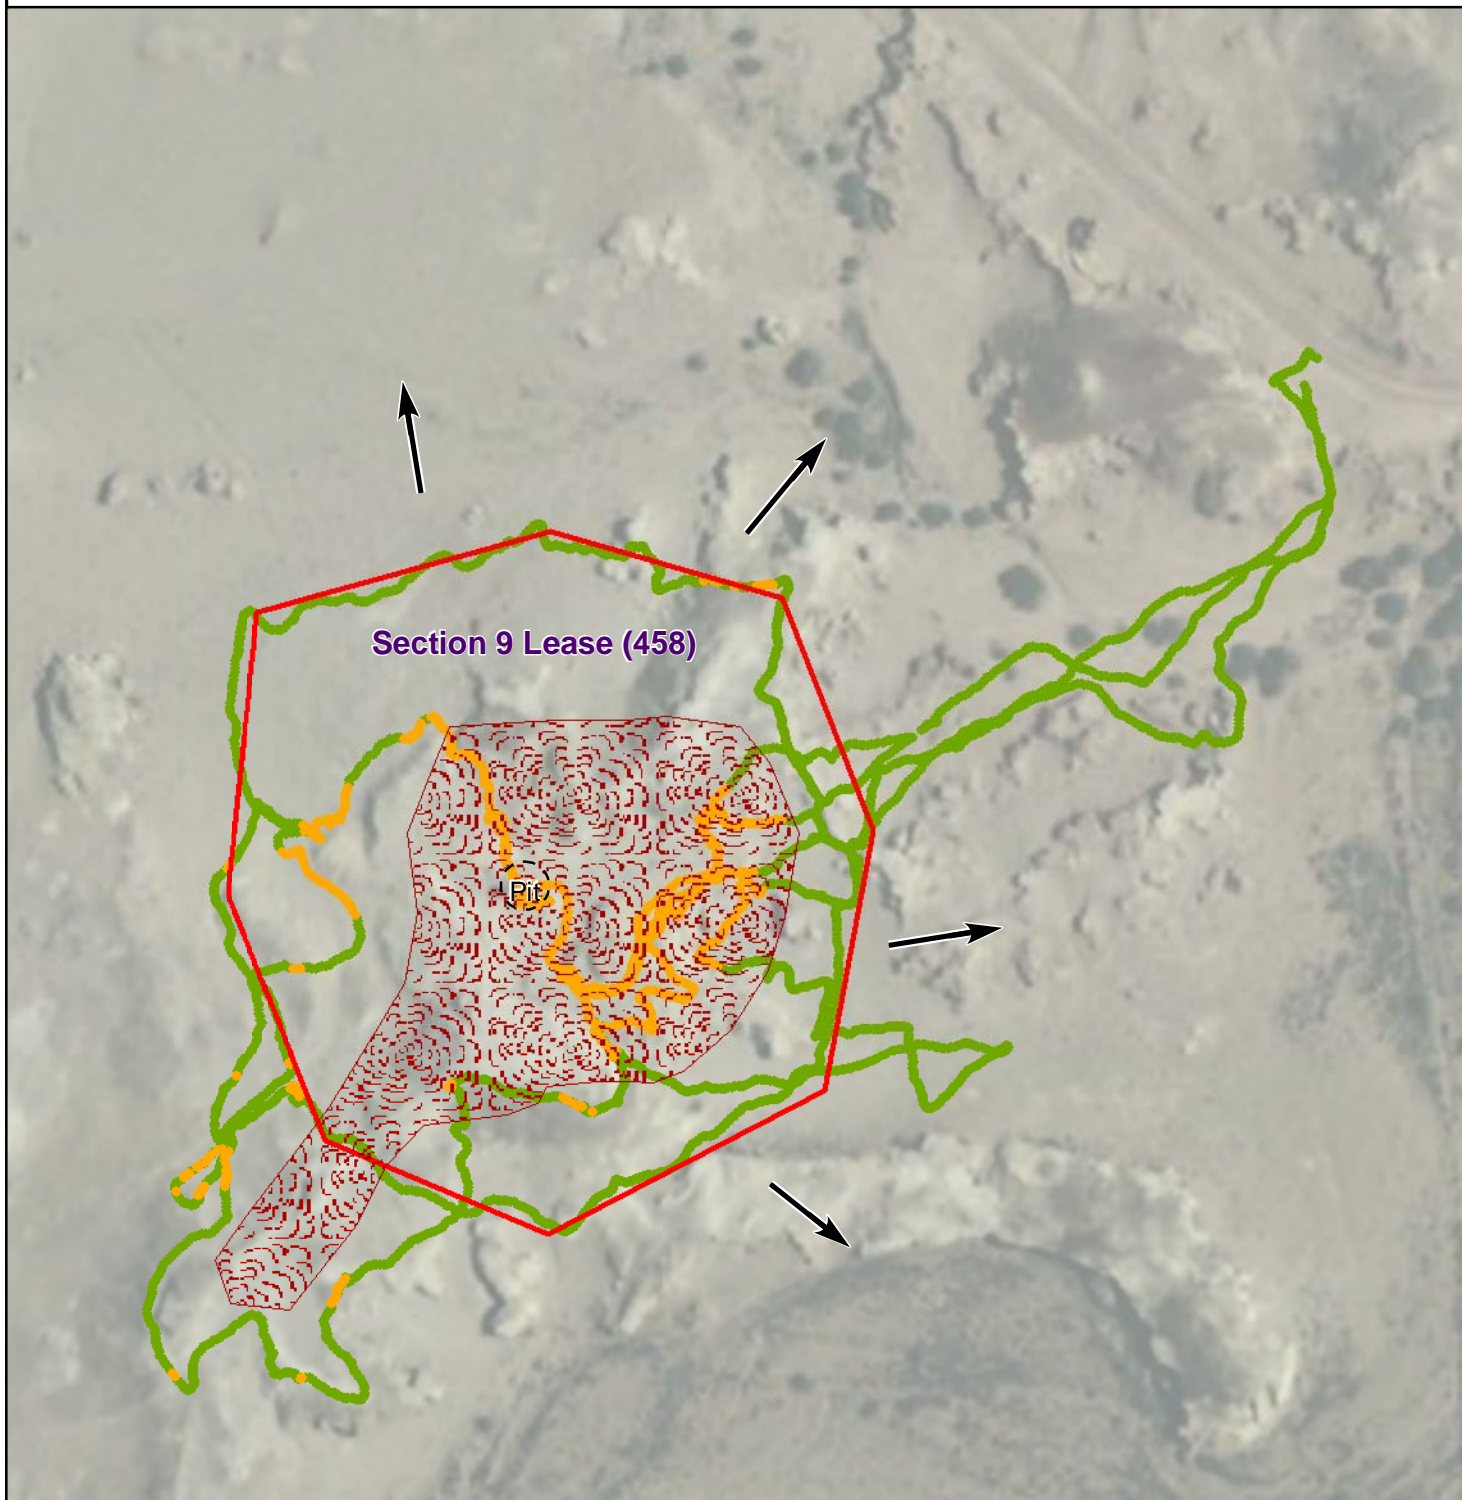
**Figure 5 - Gamma Radiation Measurements, Above Two Times Background
Section 9 Lease (458)
Coconino County, Arizona**

Gamma survey conducted 11/2010
Measured as counts per minute (cpm)

A total of 7,037 gamma radiation measurements were collected from the mine site, ranging from 10,725 cpm to 968,863 cpm. The measurements collected along the edge of the waste rock area were found at a maximum level of approximately 150,000 cpm, in the center of the waste rock area at a maximum level of approximately 1,000,000 cpm, and at possible pit area at a maximum level of approximately 300,000 cpm. The measurements are represented in Figures 1, 2, 5, and 6.
